ITS NUMBER 2

Interpreting The Secretary of the Interior's Standards for Rehabilitation

Subject: New Infill for Historic Garage Openings

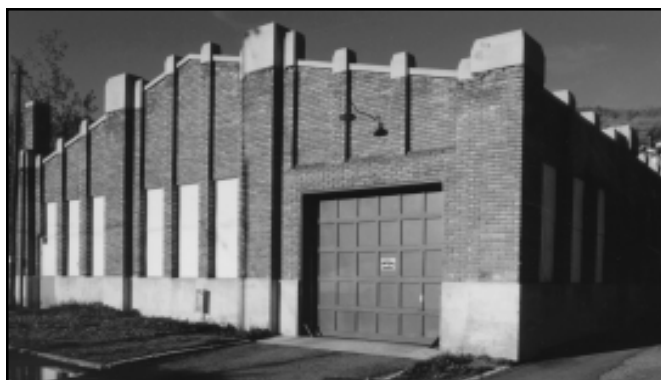
Just prior to rehab, the existing garage door was a single wood roll-up style, divided into thirty segmented solid panels by intersecting stiles and rails.

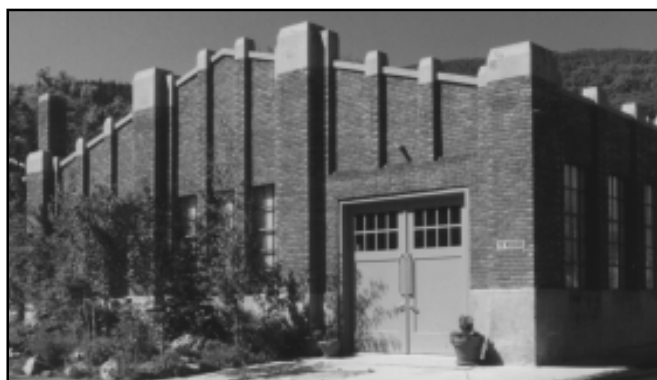
The owner chose to duplicate the original garage doors. The new doors preserved the industrial character of the historic building.

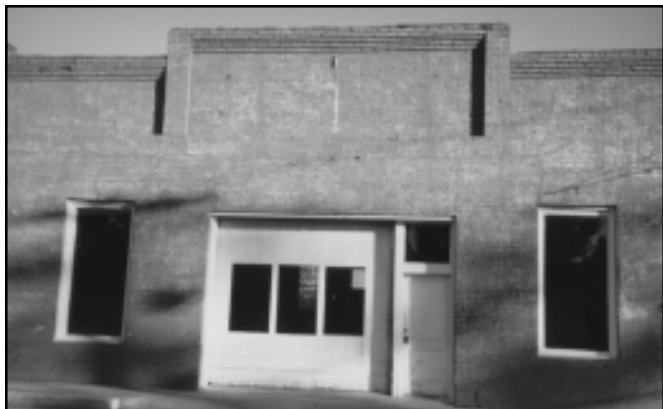
Before the work began, the original 1930 garage door opening had an operable garage door and a pedestrian door surmounted by a glazed transom installed as infill.

Application 2 (*Incompatible treatment*): A second example involves the conversion of a single story, 1930 building in a historic district, from light industrial use to office/residential use. Plans included infilling a large historic garage door opening on the principal elevation. Before rehabilitation, the opening contained an operable garage door and a pedestrian door surmounted by a glazed transom. During the rehabilitation, the owner removed the door units and installed an early-20th century style storefront in the opening, thereby creating a change incompatible with the building's historic character.

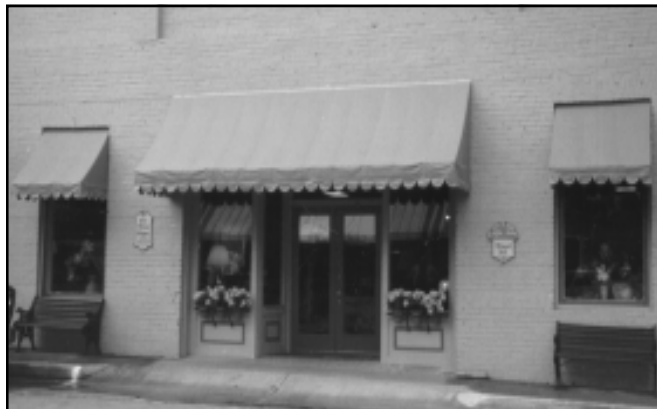
During rehabilitation the owner infilled the garage door opening with a storefront reminiscent of those used in the early-20th century, which is not in keeping with the historic character of the building.

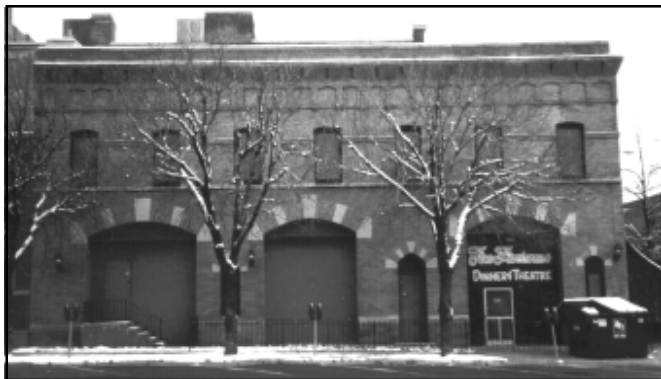
The south elevation of the 1903 firehouse is dominated by three large garage door openings. This photo was taken just prior to rehab and shows the existing infill treatments.

Application 3 (*Compatible treatment*): A 1903 firehouse, located within a historic district, was recently converted into a restaurant. The rehabilitation included infilling a series of three, segmental arched garage door openings. Historically, these openings contained firehouse doors. In 1972, these openings were infilled with concrete masonry. During the rehabilitation the current owner removed the inappropriate masonry infill and installed replacement garage doors with glazed transoms. The design of the new doors consists of multi-paned units, each divided into 16 segmented panels by intersecting stiles and rails. The panels are infilled with three rows of clear tempered glass and V-groove wood siding at the base. This compatible contemporary treatment of the replacement garage doors maintains the historic character of the building, while providing the openness sought by the new owner.

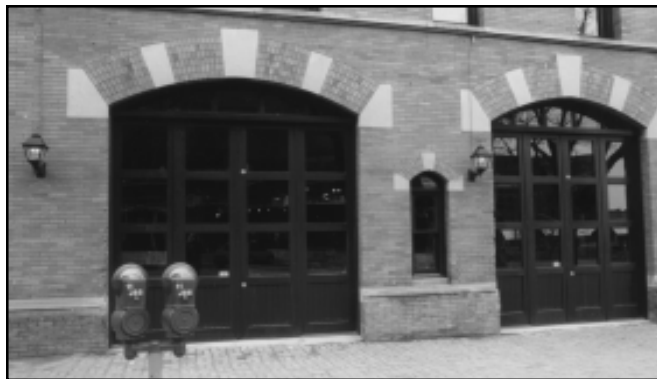
The design of the replacement doors is articulated with multi-paned units, maintaining the historic character of the building.
